A report on Chautara prefabricated structure at Chautara District Hospital in Sindhupalchowk district

Introduction

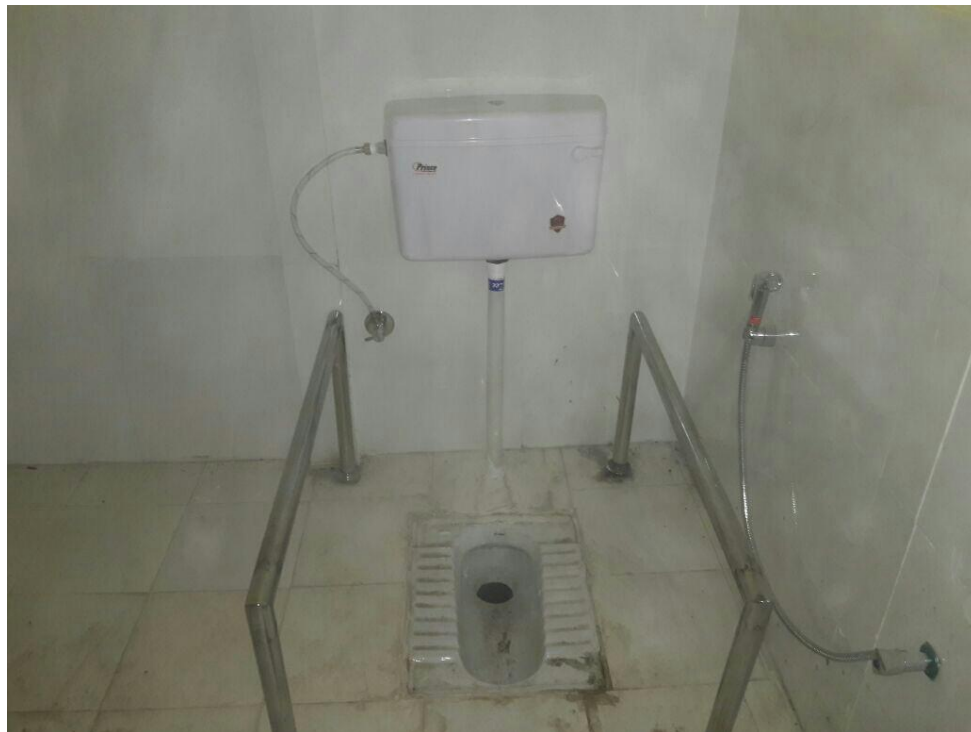
1. Installation of connector pipe is not proper in all toilets:

Proper connector pipes have been installed in all toilets

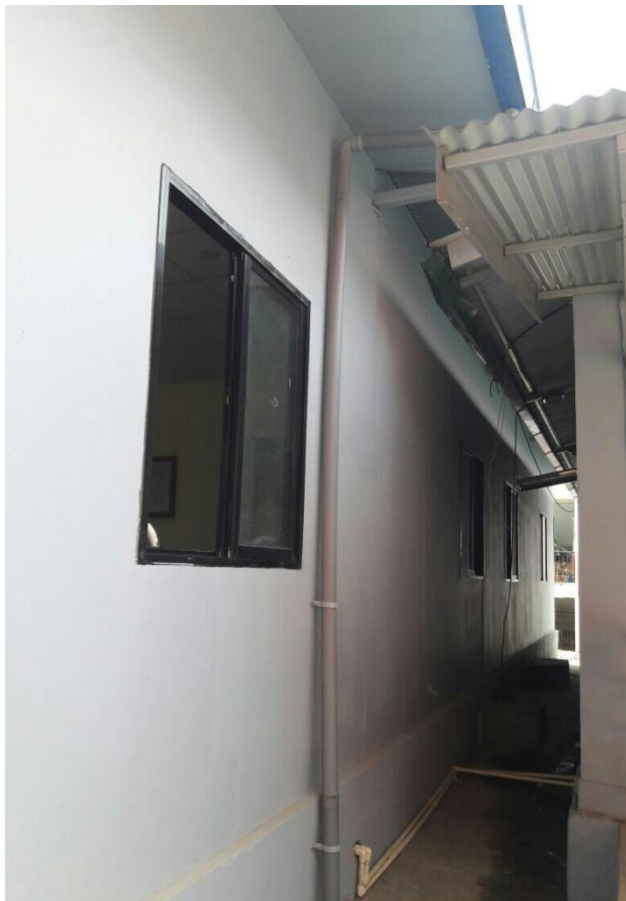
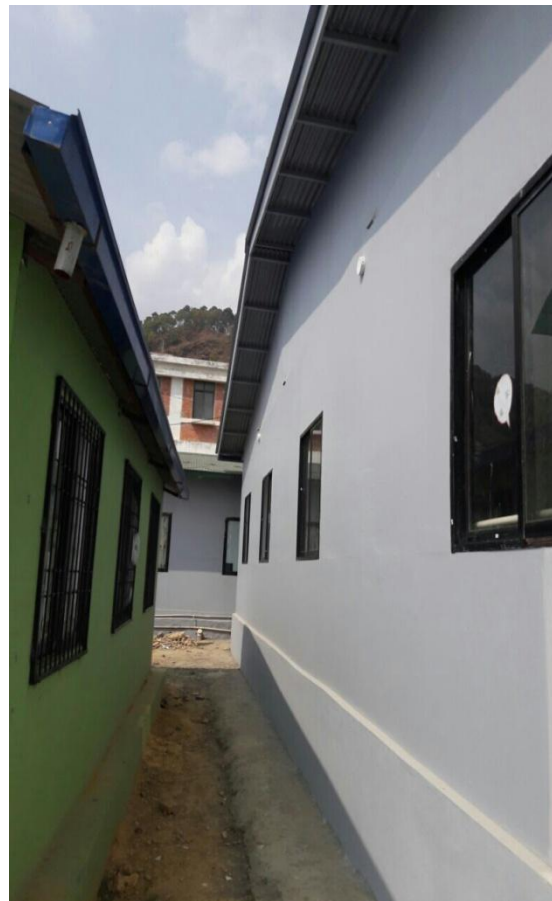
2. Apron drain is constructed only in the southern side of the building but the outlet of this drain is not seen. In the rest of the side apron were not constructed properly:

The Chautara district hospital lacks a proper water drainage system and they are not sure enough where to make the outlet for the proper water drainage system. As our contractor including us did not get any proper information regarding the outlet of the drain, we could not construct the effective outlet system. We have requested the DHO (Mrs. Poma) to allocate a proper space for the water drainage system.

The apron could not be constructed as per the design because of the space crunch and a leftover space just at the front of prefabricated structure for proper access to vehicles as well as the patients. The prefabricated structure is just besides another structure on other sides and the leftover space is covered by the roof of the corrugated steel sheets. An apron drain could be constructed but our contractor did not find the need of the apron drain there.

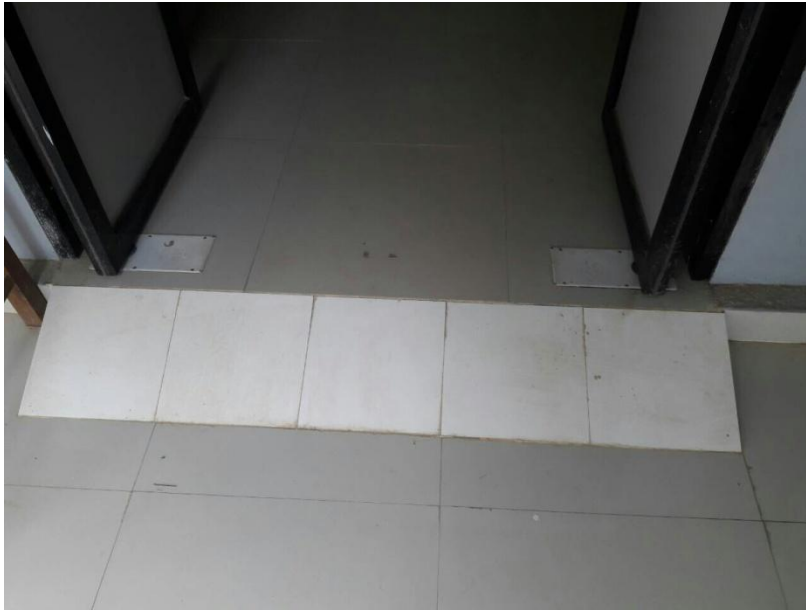
3. A step has been kept just at the main door that impedes the free access of wheel chair and trolley inside the building:

A ramp has been constructed at the main door.

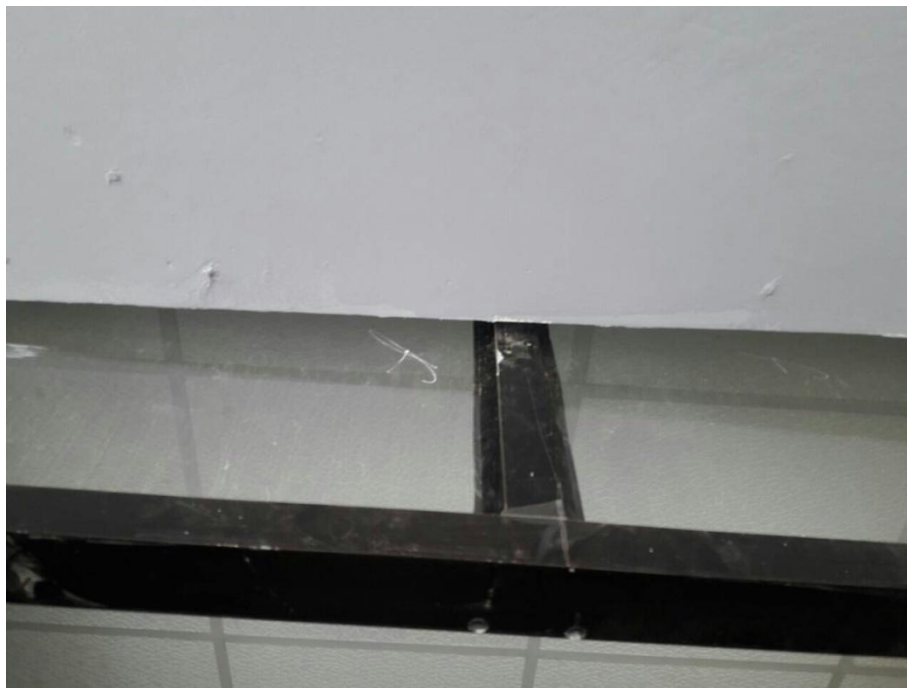
4. Skirt roof just above the main door is not properly sealed:

The corrugated steel sheet has been added just above the main door to disallow the rain water from entering from the skirt roof and the main door has been sealed.

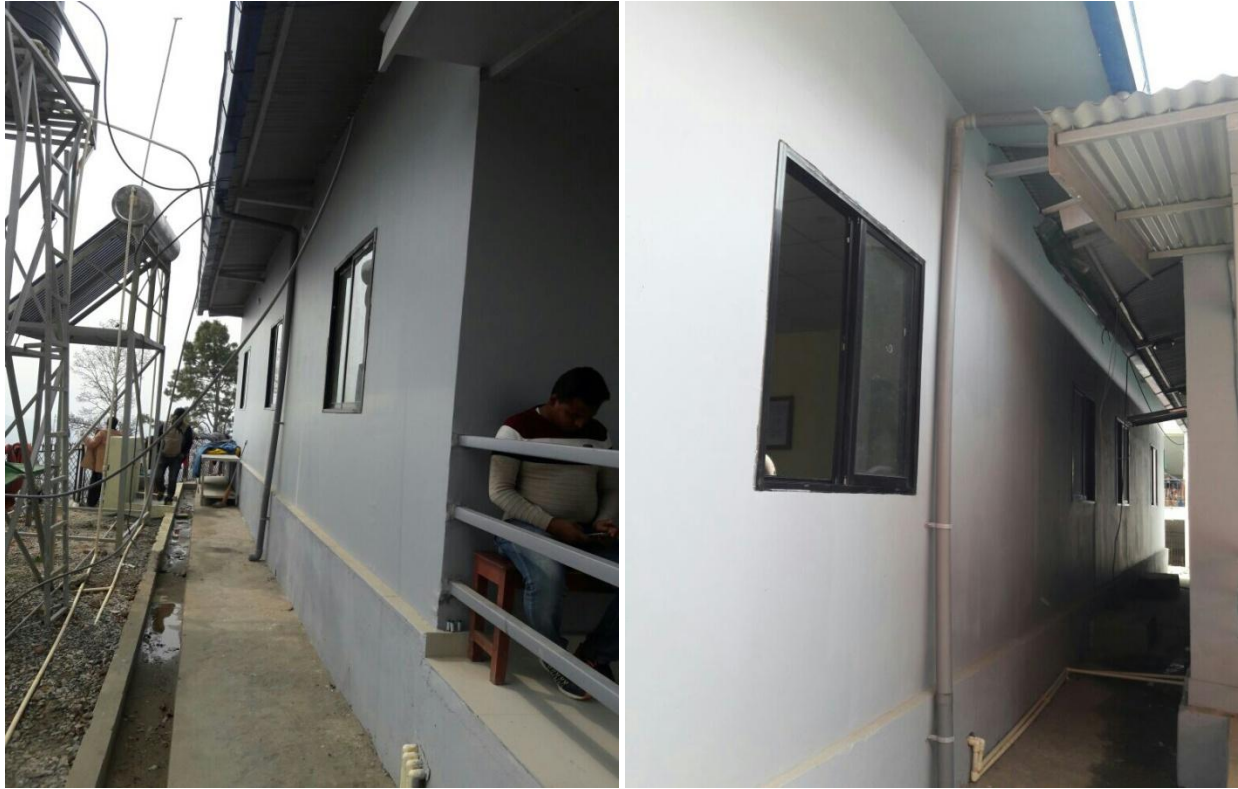
5. **Roof gutter are installed. The level and slope has to be checked to ensure the proper flow of water. No conveyor pipes were seen to take the water to the drain. The ends of roof gutter are left open to let the water drip down from the gutter:**

Conveyor pipes has been installed to take water from the gutter up to the drain

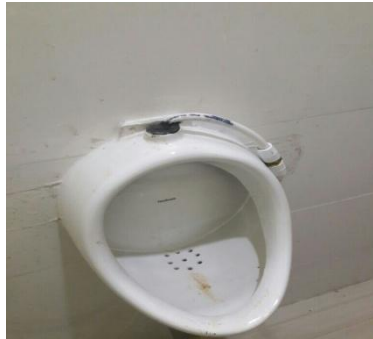
- *Toilet layout in female toilets has been changed. Some pipe inlets are seen open. This toilet consists of 3 wash basins for 1 person. The spray pipes (ablution tap) are broken:*

The layout of the toilet has been changed due to the space crunch and to make available space more effective. An additional prefabricated toilet has been constructed to supplement the deducted space as per the request from the DHO. Two urinals have been installed replacing the previously constructed basins. The spray pipes are mended.

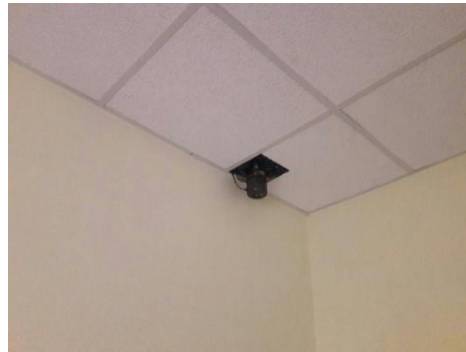
- *Female toilets are lacking ventilations. Exhaust fan with proper ducting should be installed to vent this space:*

Exhaust fans with proper ducting have been installed for proper air flow

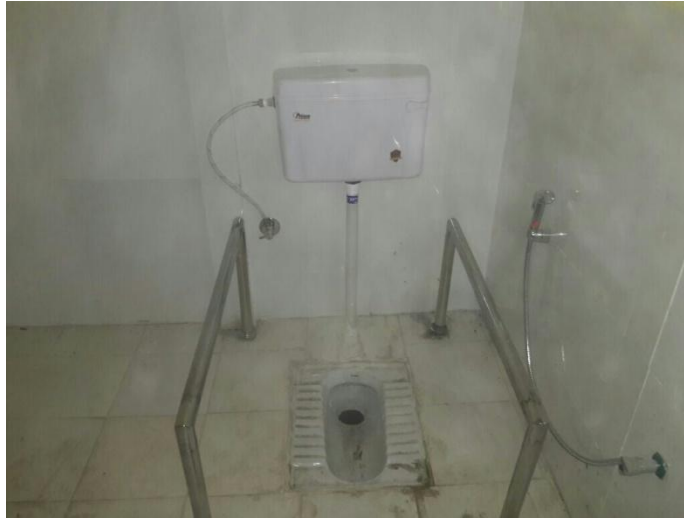
- *Grab bars in disabled toilets are missing. Also, fixture is not installed as per approved design:*

Grab bars are already installed.

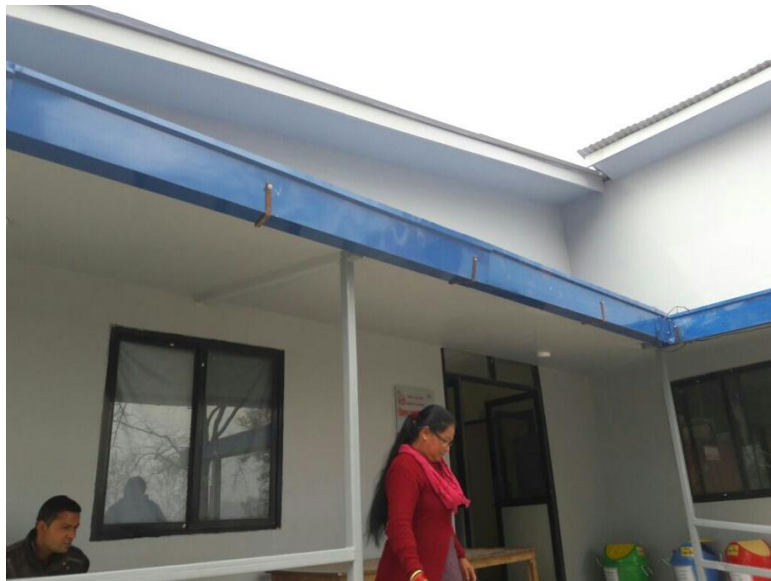
- *Edge of the metal square pipes should be closed by welding metal caps:*

The edges of the metal square pipes have been welded by metal caps.
